ARCHAEOLOGICAL SURVEY  
AT THE PROPOSED DOUGLASS LAKE  
BUTLER COUNTY, KANSAS  
1987

Dorothy J. Gaston  
Project Director

Report to  
U.S. Army Corps of Engineers  
Tulsa District

University of Tulsa  
Laboratory of Archaeology  
1988

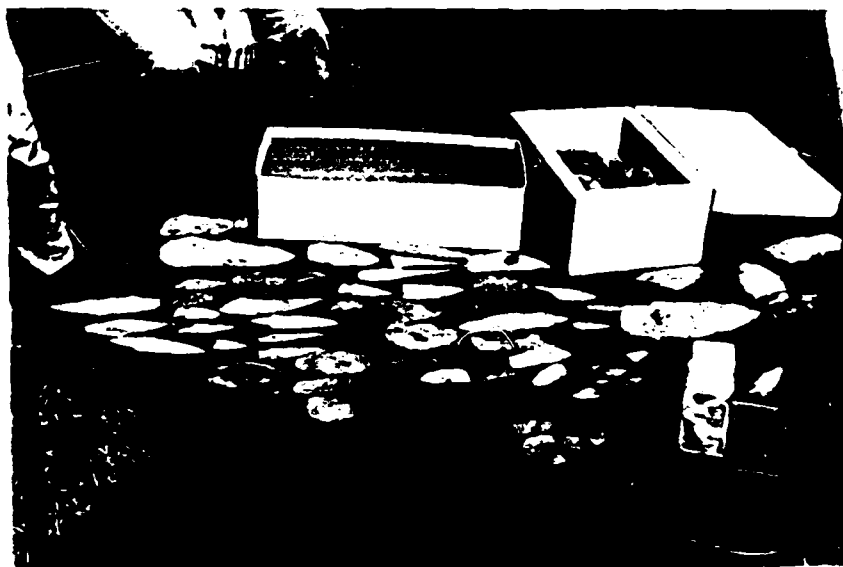
Plate 3. Private Collection. Large points and bifaces are from X-03.

Although this site could not be relocated due to heavy undergrowth, the landowner was very positive about its location. His collection (Plate 3), indicates the likelihood of a Chelsea Phase Archaic site. The landowner reports that artifacts were turned up with deep-plowing, but that none have been noted since that technique was abandoned about twenty years ago. This suggests that the site is largely undisturbed, and should be investigated. If deeper deposits are present, this site might be utilized to examine the earlier archaic record which was poorly represented at El Dorado Lake. It is located on an eroded Verdigris terrace on the north side of Hickory Creek, about two miles east of its confluence with the Little Walnut River.

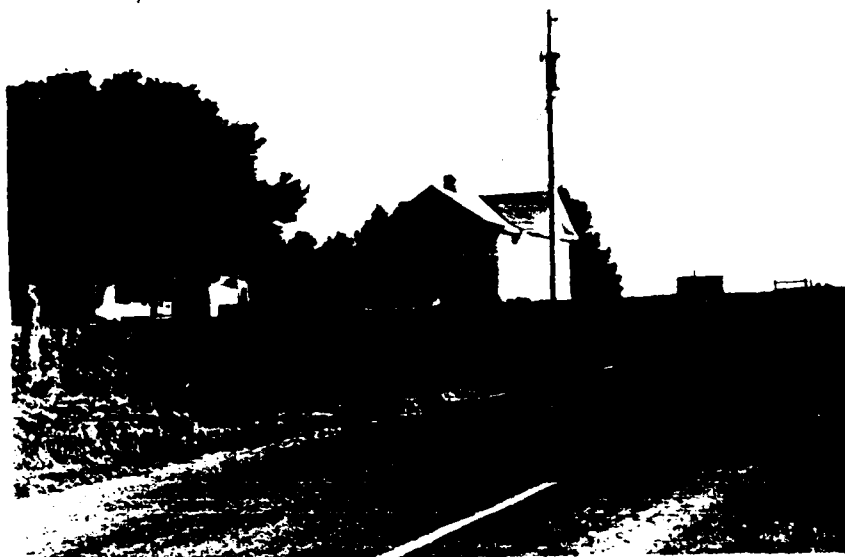
Plate 7. Webster Church

This structure is located in the NE/4, NE/4, NE/4, NE/4 of Section 16, T28S, R5E, at an elevation of 1290 to 1300 feet asml. It is presently in use as Webster Church. Architecturally, it is a unique example of country schools in the area. It has been given more ornate detail in construction, such as the eave supports and window details (Plates 7 and 8). It is probably not the original structure indicated on the GLO maps, its construction probably dates to the late nineteenth cen-

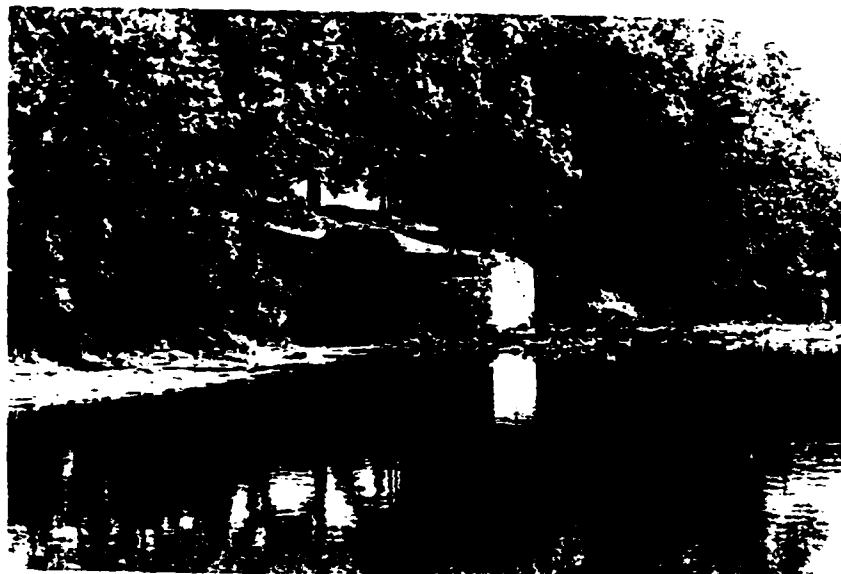
Plate 13. Western Approach to Bois d'Arc Dam

This dam was located in the NE/4, SE/4 of Section 19, T28S, R5E at an elevation of 1230 to 1240 feet asml. It is located on the Little Walnut River southwest of its conjunction with Hickory Creek (Figure 2, Figure 9). It was of concrete construction. Although the dam was dynamited during the 1940s, the approaches and foundations remain in place (Plates 13 and 14). While it could not be confirmed, the dynamiting was probably required due to build-up of debris behind the dam following the intensive flooding in the early 1940s. Portions of the dam itself now lie in the river bed to the south of the original location. A fragment of the inscribed date was found on the eastern bank by the present owner (Plate 15), but, unfortunately, lacked the year.

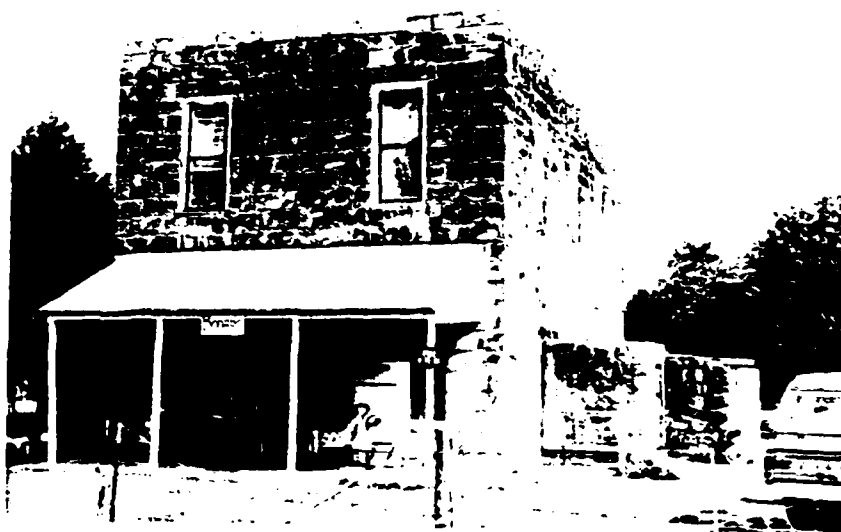
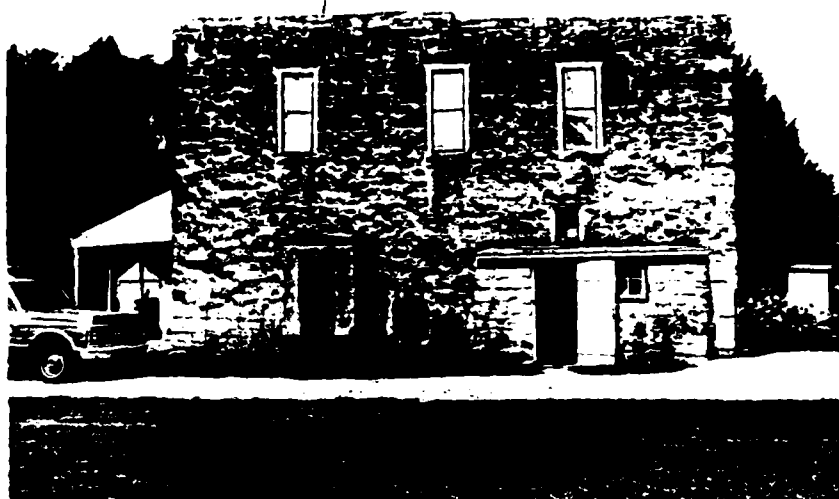
Plate 16. Bodarc Store, south side.

This stone masonry building has been moderately well-maintained. It suffered some damage during the flooding in 1976 which inundated the lower floor. The present owner indicated an inability to pay for further maintenance. It is not clear from the maps whether or it would be endangered by dam construction, but it would certainly be subject to floodstage water releases. It is recommended that an effort be made to preserve this building.

This structure is located in the NW/4, SE/4 of Section 19, T28S, R5E at an elevation of 1240 feet asml (Figure 9, Plates 16 and 17). Although some local lore suggests that this building was constructed of materials from the mill, the date of destruction of the mill is much later than many of the dates inscribed on the storefront (Plate 18).

A commemorative plate depicting the store was issued during the 1920s. It was probably in commemoration of its 50th year, placing construction ca. 1875. The masonwork, as well as the staining of the native limestone, suggest that it was contemporaneous with the mill.

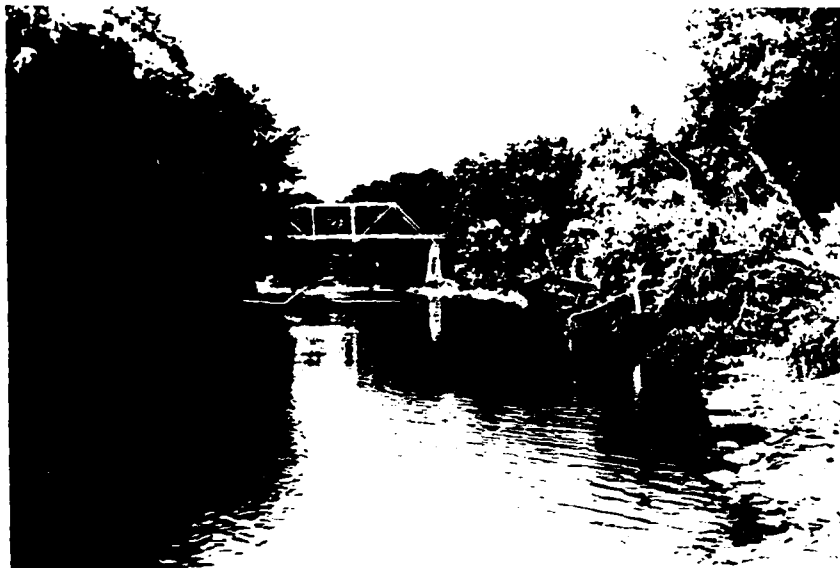
Plate 19. Bois d'Arc Bridge, looking south.

This bridge spans the Little Walnut River in the NW/4, SE/4 of Section 19, T28S, R5E, at an elevation of 1240 feet asml (Figure 9, Plate 19). The bridge supports are of stone masonry on concrete footings. The span is of angle iron and the bridge floor is wooden plank. No construction date could be located on the bridge itself. The masonry appears to be contemporary with that of the store. A retaining wall of large limestone blocks was constructed on the west bank just south of the bridge (Plate 20). It is suggested that an effort be made to preserve this bridge.

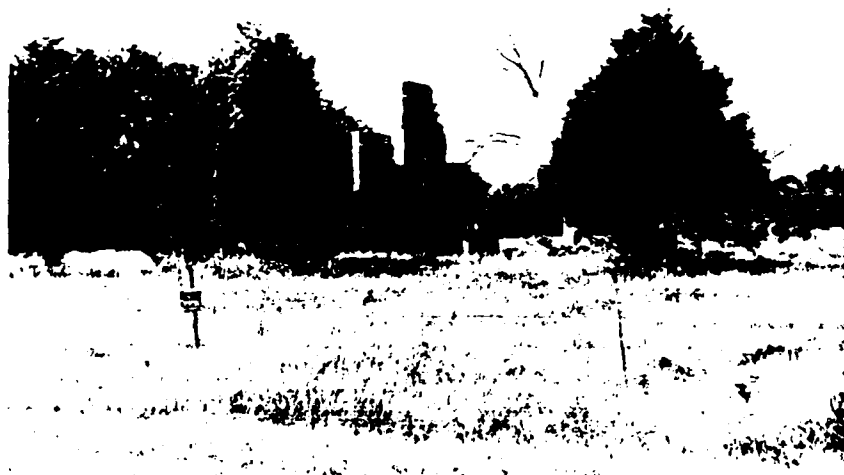
Plate 21. Bloomington Church, looking northwest.

This structure is located in the SW/4, SW/4, SE/4 of Section 26, T28S, R5E, at an elevation of 1340 to 1350 feet asml. It has been partially demolished (Plate 21). The basic construction was of red brick. The site is not endangered by the proposed lake.

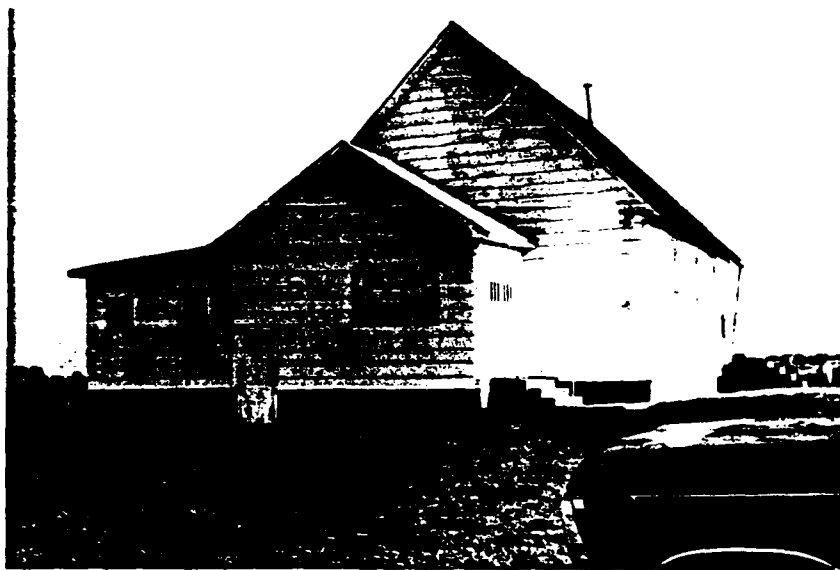
Plate 24. Zion Church, looking north.

This structure, originally a country schoolhouse (Plate 24), is located in the SW/4, SW/4 of Section 33, T28S,
